ST	GTA02	8 LAYER
	FIC011	
LAYER:	SILKSCREEN (TOP)	
DATE:	2007-12-20 12:00	
Clearance error		8
Connectivity error		0

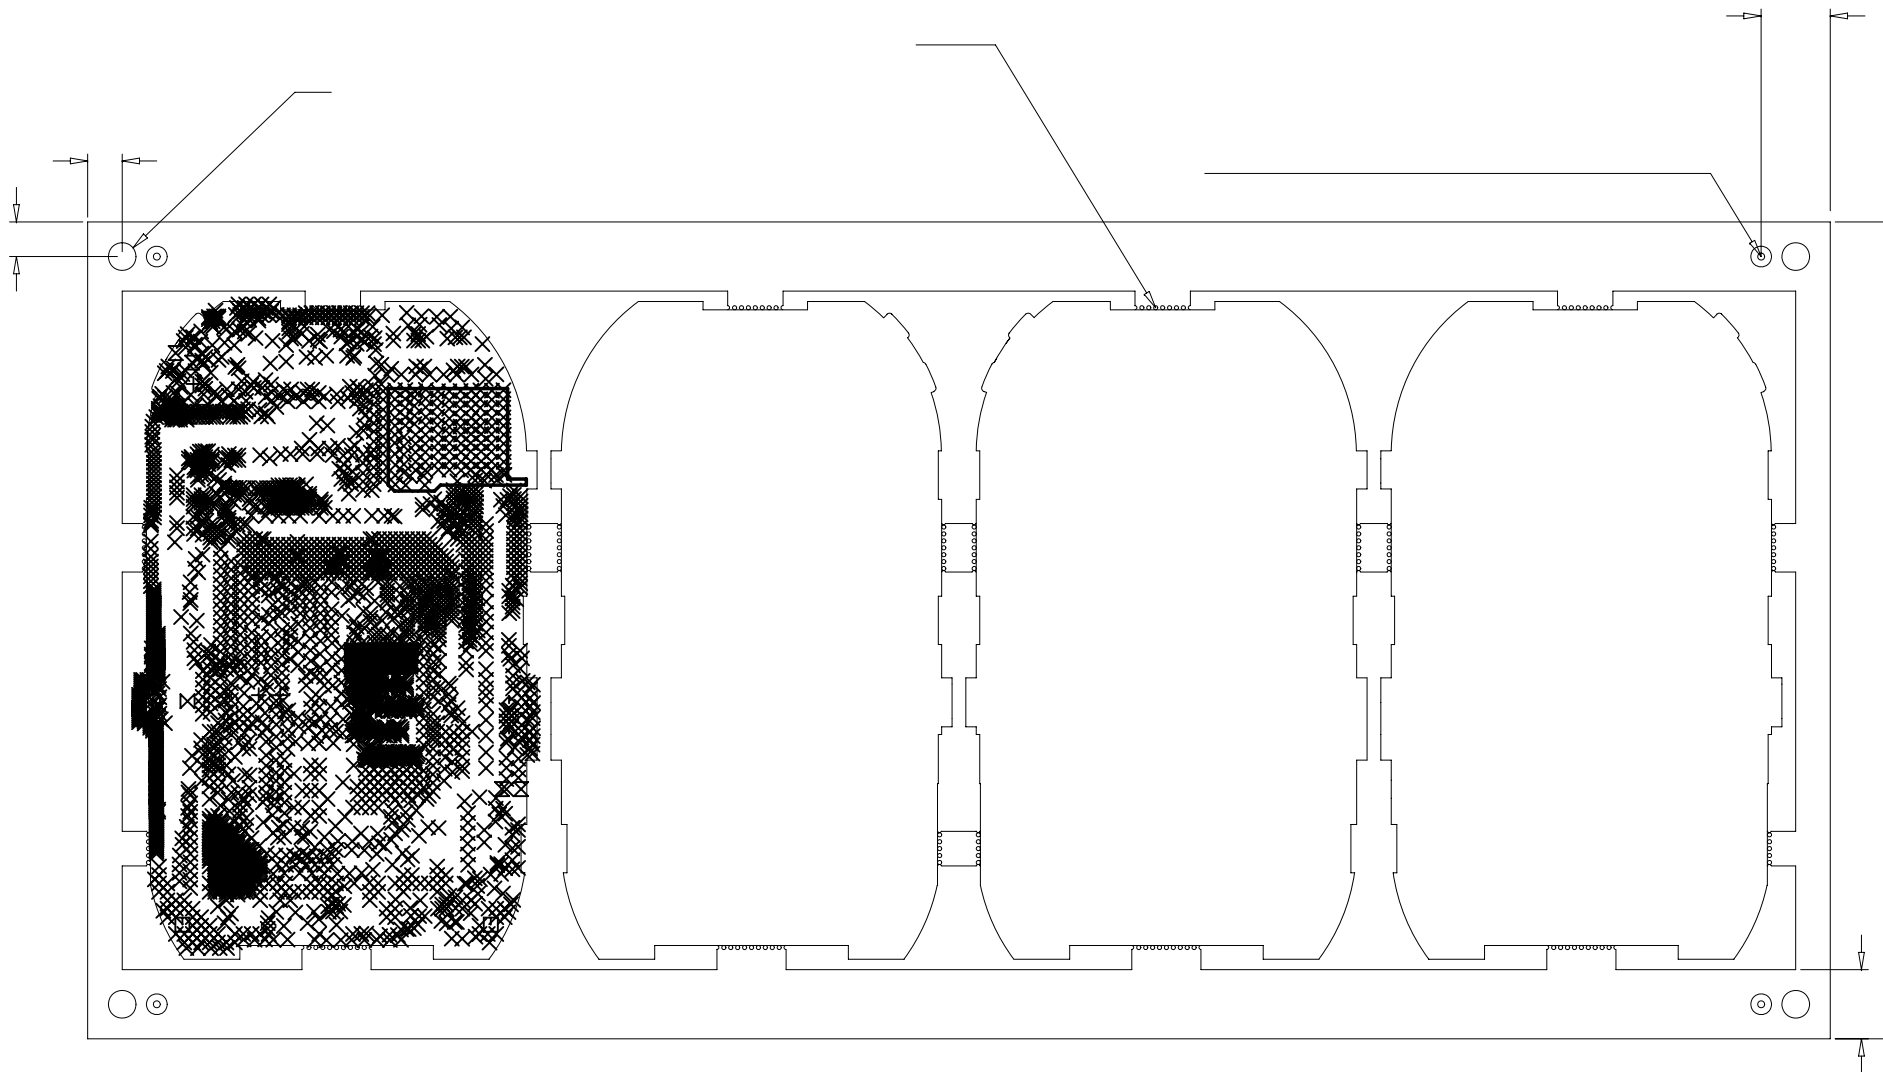
ST	GTA02	8 LAYER
	FIC011	
LAYER: L1 TOP SIDE		DRILL
DATE: 2007-12-20 12:00		
Clearance error		8
Connectivity error		0

SIZE	QTY	SYM	PLATED	TOL
4	3071	✕	YES	+/-0.0
78.74	2	□	YES	+/-0.0
35.43	2	◇	NO	+/-0.0
29.53	4	⊠	NO	+/-0.0
59.06	2	⊞	NO	+/-0.0
43.31	2	+ ^A	NO	+/-0.0
80	1	+ ^B	NO	+/-0.0

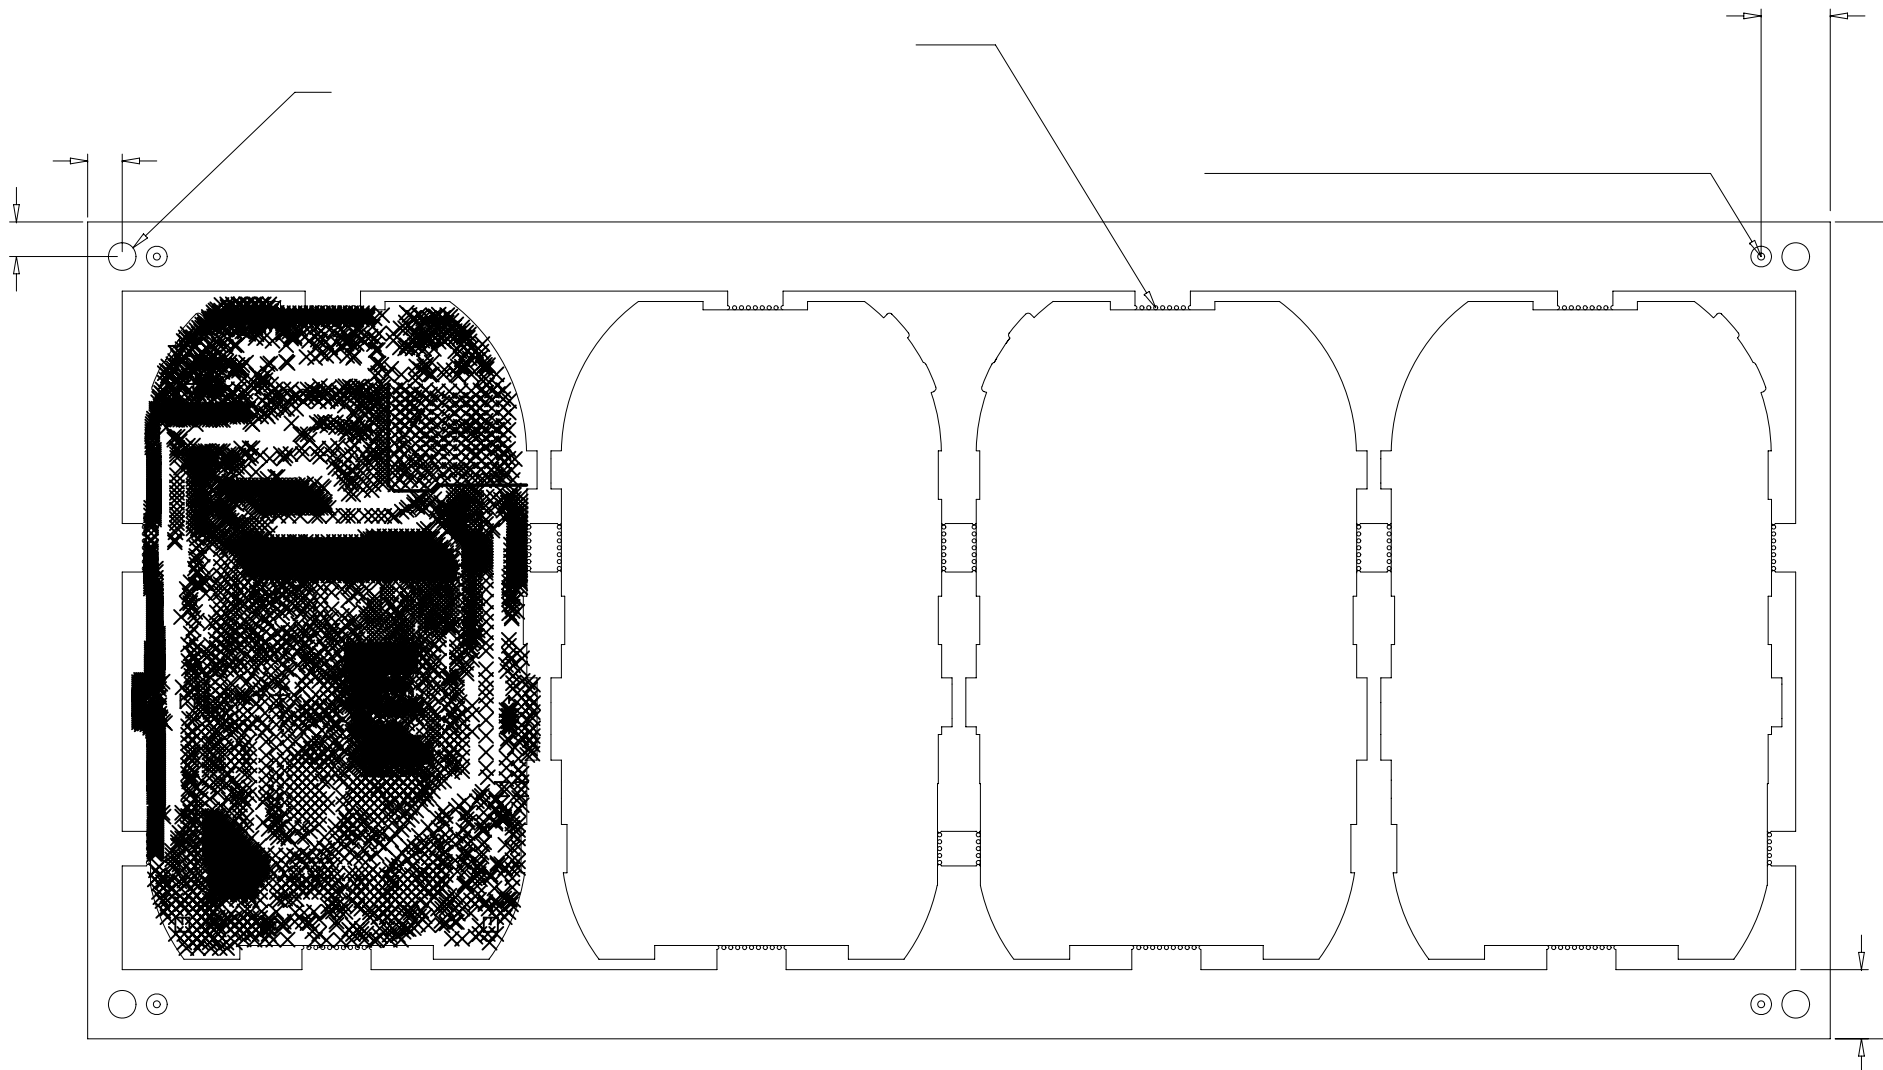
ST	GTA02	8 LAYER
	FIC011	
LAYER: L2 GND(TRK)		DRILL
DATE: 2007-12-20 12:00		
Clearance error		8
Connectivity error		0

SIZE	QTY	SYM	PLATED	TOL
78.74	2	□	YES	+/-0.0
35.43	2	◇	NO	+/-0.0
29.53	4	⊗	NO	+/-0.0
59.06	2	⊗	NO	+/-0.0
43.31	2	+ ^A	NO	+/-0.0
80	1	+ ^B	NO	+/-0.0

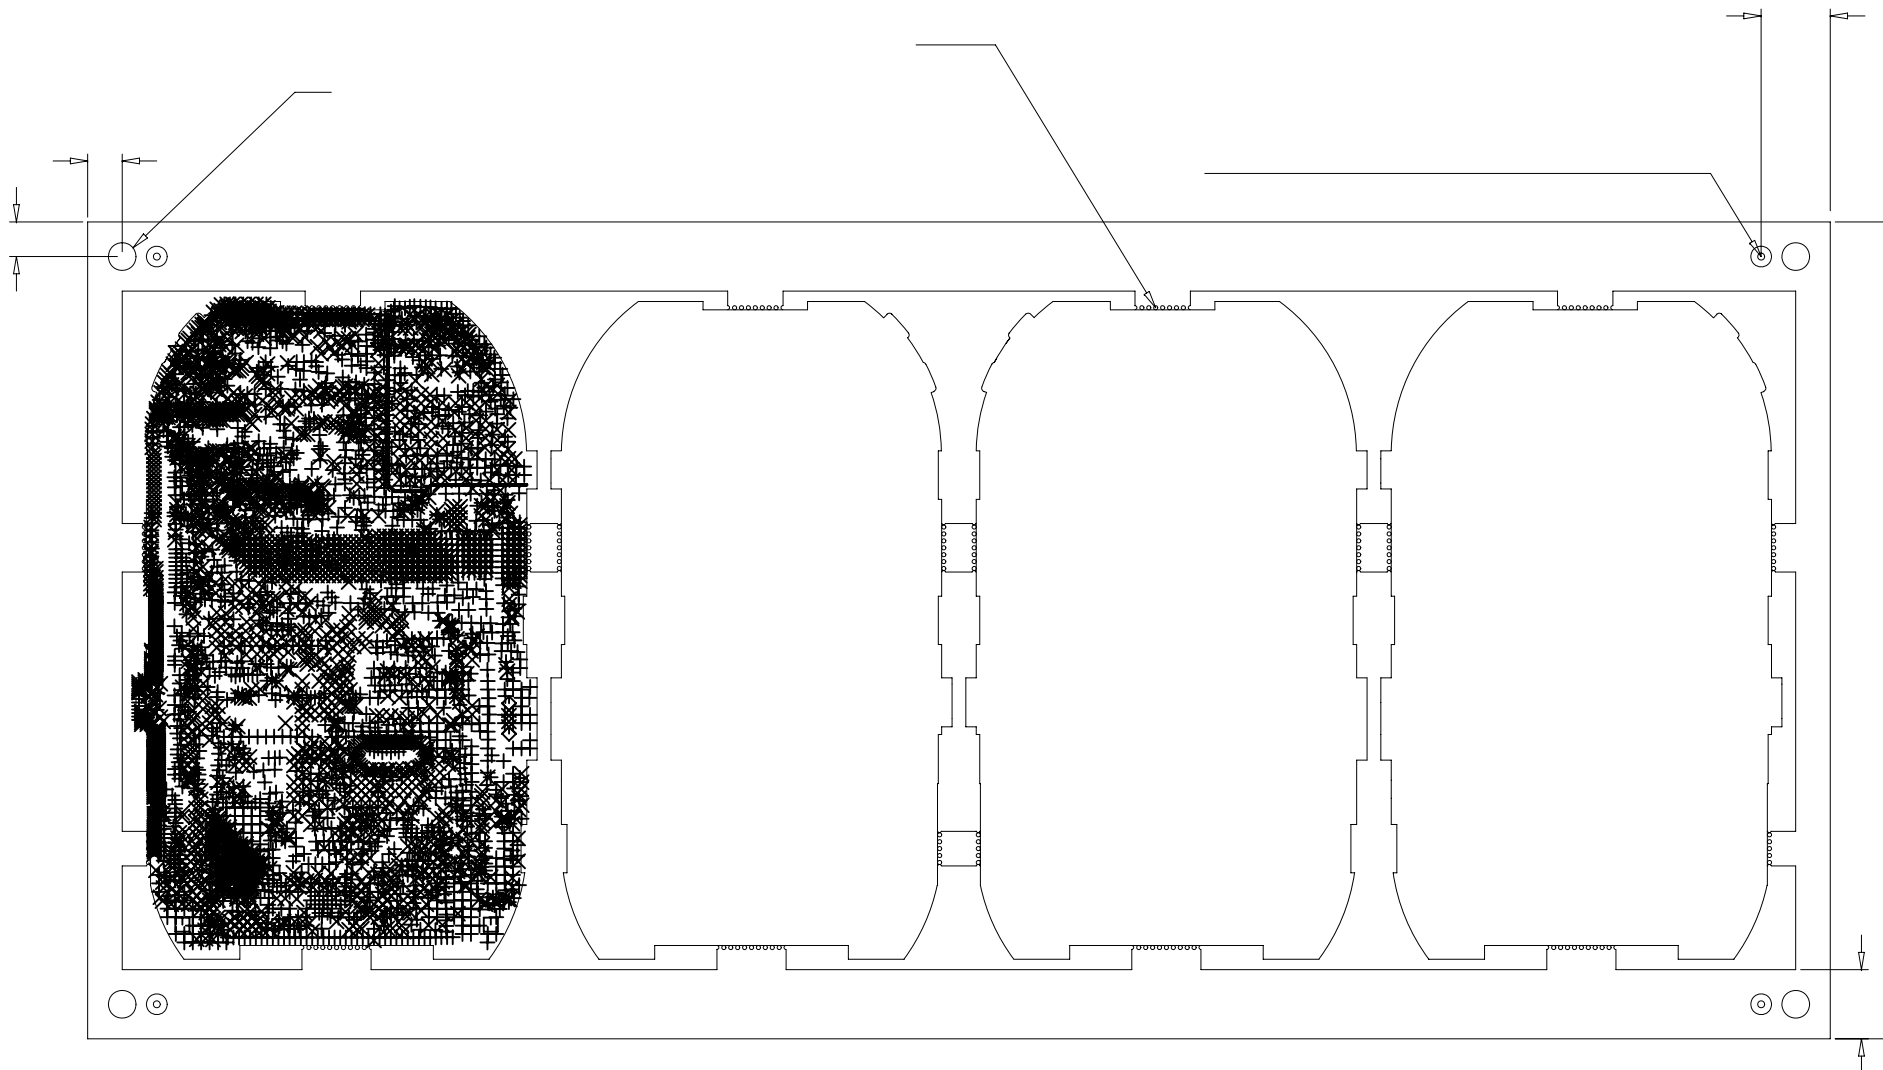
ST	GTA02	8 LAYER
	FIC011	
LAYER:	L3 GND(TRK)	DRILL
DATE:	2007-12-20 12:00	
Clearance error		8
Connectivity error		0

SIZE	QTY	SYM	PLATED	TOL
12	2356	+	YES	+/-0.0
4	2573	×	YES	+/-0.0
78.74	2	□	YES	+/-0.0
35.43	2	◇	NO	+/-0.0
29.53	4	⊠	NO	+/-0.0
59.06	2	⊠	NO	+/-0.0
43.31	2	+ ^A	NO	+/-0.0
80	1	+ ^B	NO	+/-0.0

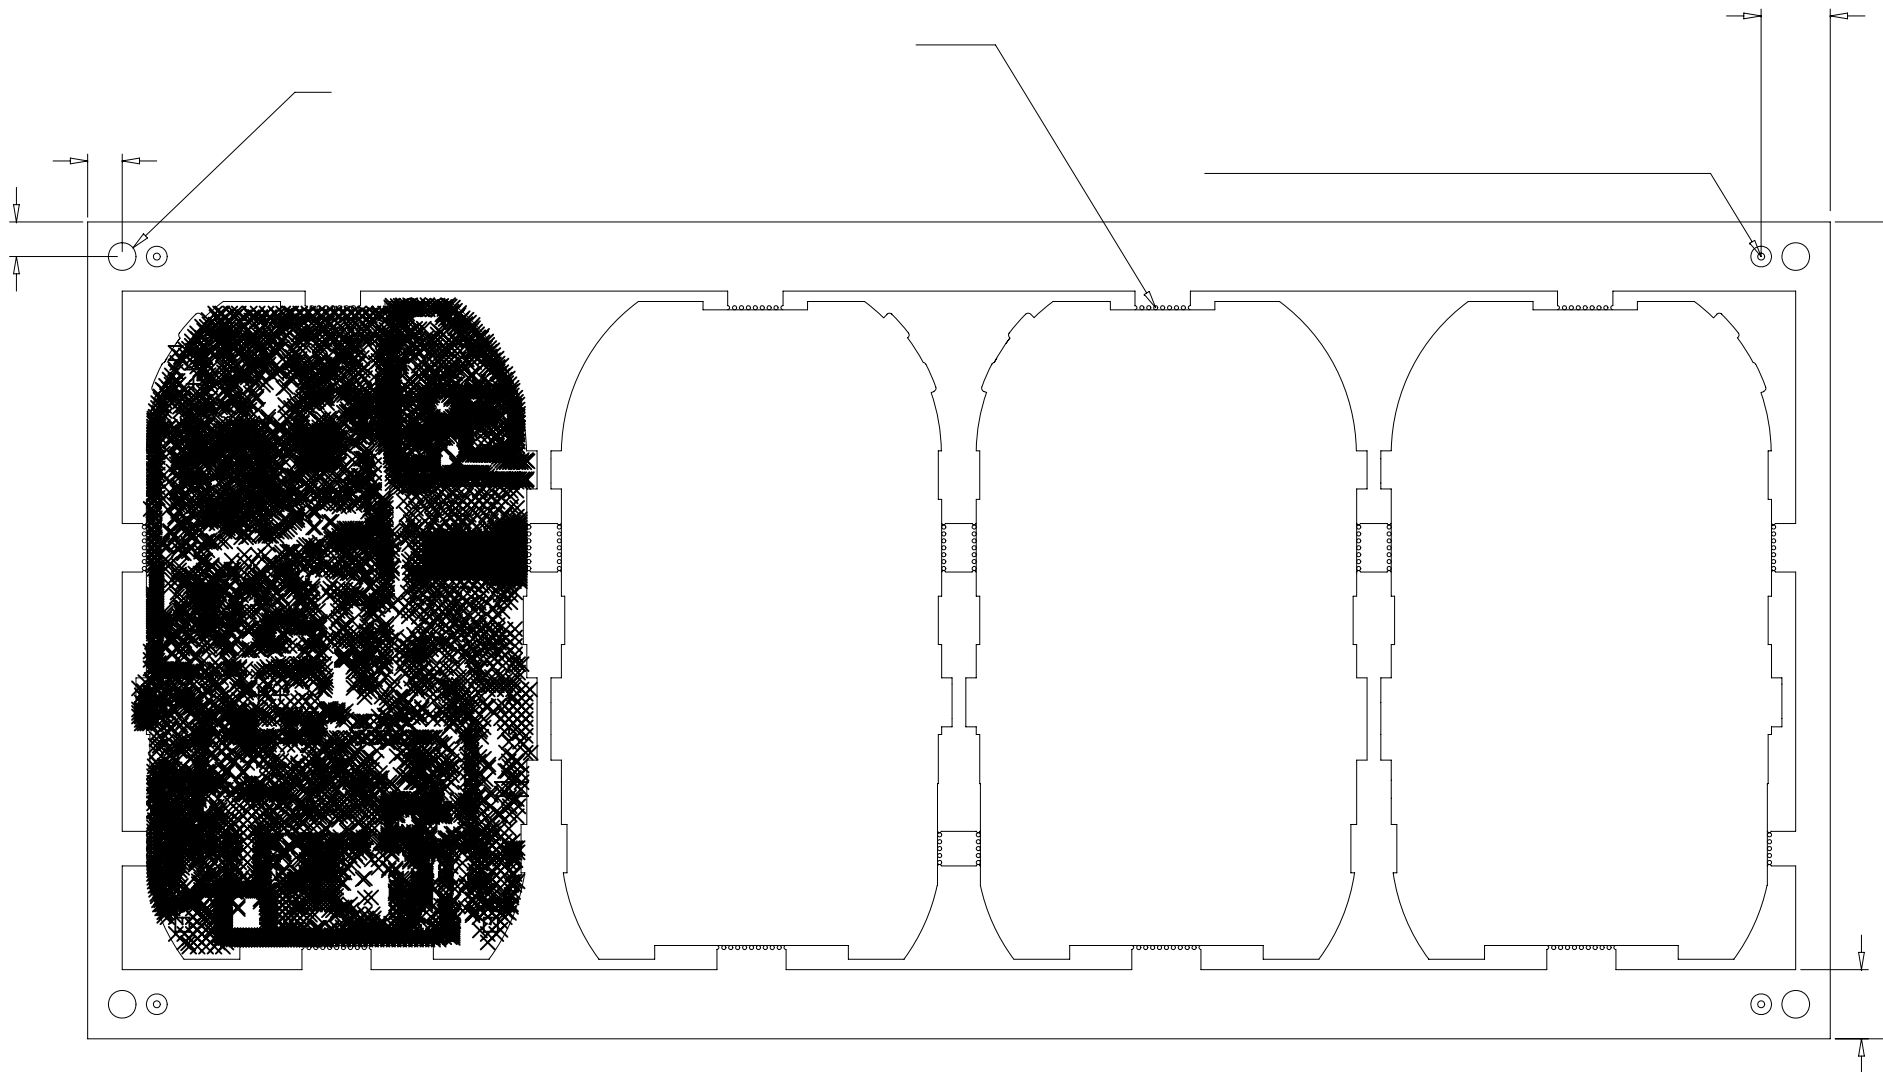
ST	GTA02	8 LAYER
	FIC011	
LAYER:	L7 GND(TRK)	DRILL
DATE:	2007-12-20 12:00	
Clearance error		8
Connectivity error		0

SIZE	QTY	SYM	PLATED	TOL
4	7176	✕	YES	+/-0.0
78.74	2	□	YES	+/-0.0
35.43	2	◇	NO	+/-0.0
29.53	4	⊠	NO	+/-0.0
59.06	2	⊞	NO	+/-0.0
43.31	2	⊕	NO	+/-0.0
80	1	⊕	NO	+/-0.0

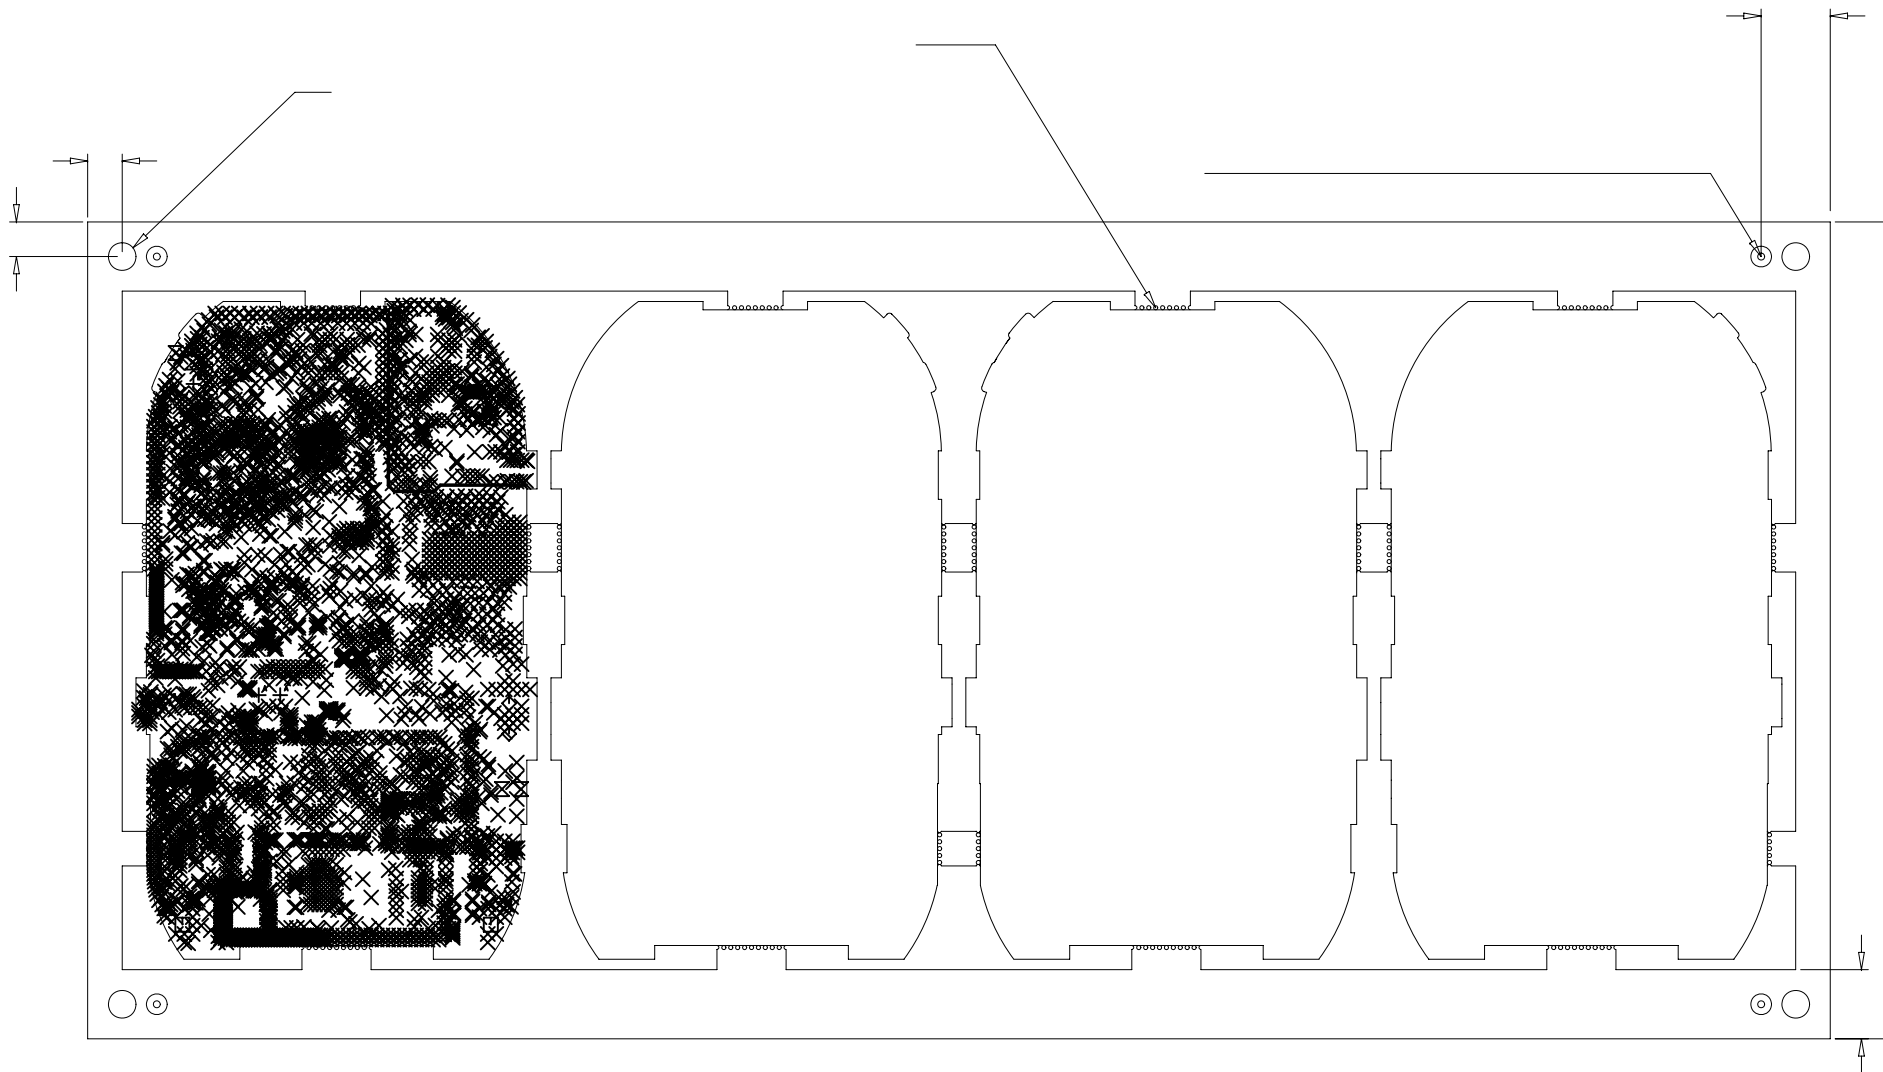
ST	GTA02	8 LAYER
	FIC011	
LAYER:	SOLDER SIDE	
DATE:	2007-12-20 12:00	
Clearance error		8
Connectivity error		0

SIZE	QTY	SYM	PLATED	TOL
4	3718	×	YES	+/-0.0
78.74	2	□	YES	+/-0.0
35.43	2	◇	NO	+/-0.0
29.53	4	⊠	NO	+/-0.0
59.06	2	⊞	NO	+/-0.0
43.31	2	+ ^A	NO	+/-0.0
80	1	+ ^B	NO	+/-0.0
